Manhole Inspection Summary

Manhole # S21G1_006MH

Insp Date: **4/29/08 2:18 PM**

Location Address: **2513 banger st**

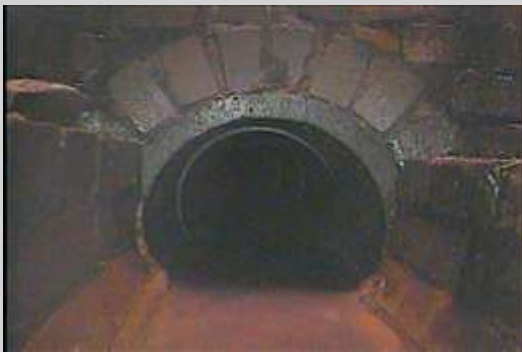
12 O'Clock Outflow

12 in. Circular Gravity Sewer
Pipe Out @ 12 O'Clock

Pipe Height: **12** (in.) Rod and Bar (Angled)
Pipe Material: **Clay** ☐ Pipe Lined
Invert Depth: **13.70** (ft.) Flow Characteristics: **Slow**
Deposits: ☒ None ☐ Mud ☐ Sludge ☐ Debris ☐ Grease
Silt Depth: **0** (in.) Deposits Extent:
Infiltration: **None** Pipe Seal Cond: **Sound**

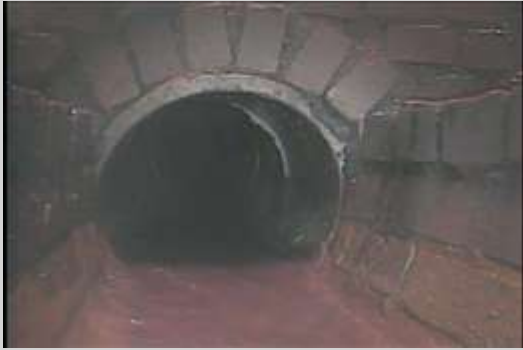
6 O'Clock Inflow

12 in. Circular Gravity Sewer
Pipe In @ 6 O'Clock

Pipe Height: **12** (in.) Rod and Bar (Angled)

Pipe Material: **Clay** ☐ Pipe Lined

Infiltration: **None** Pipe Seal Cond: **Sound**
